## Betaflex Pro Ink Mottle Analysis

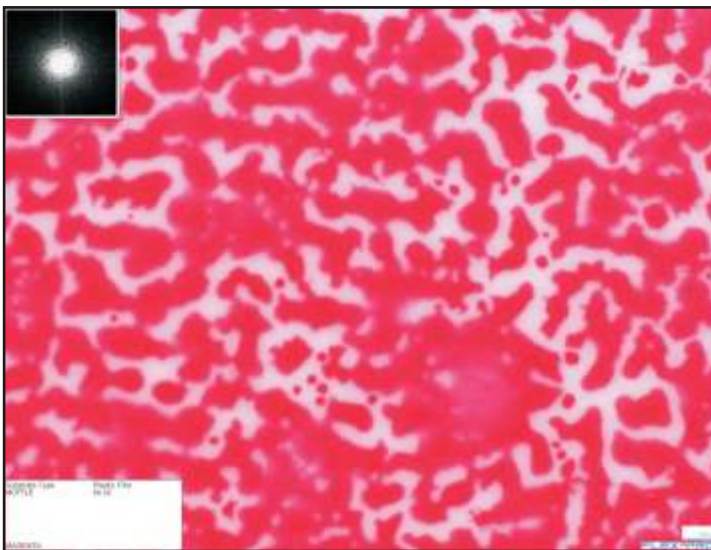
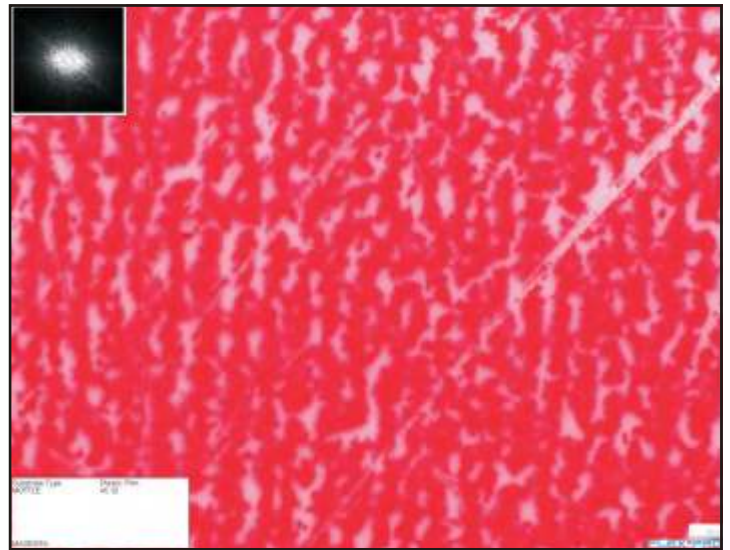
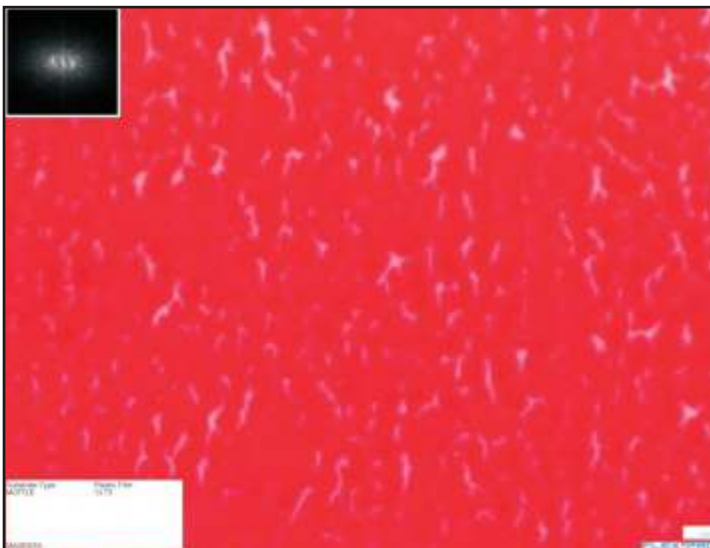
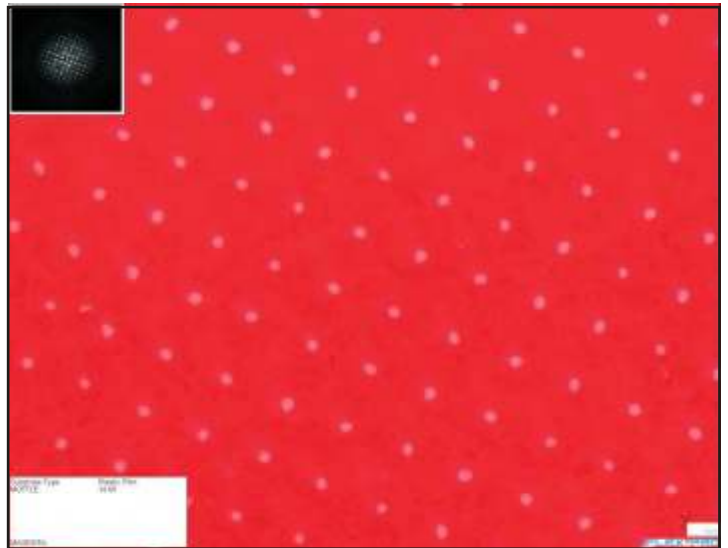
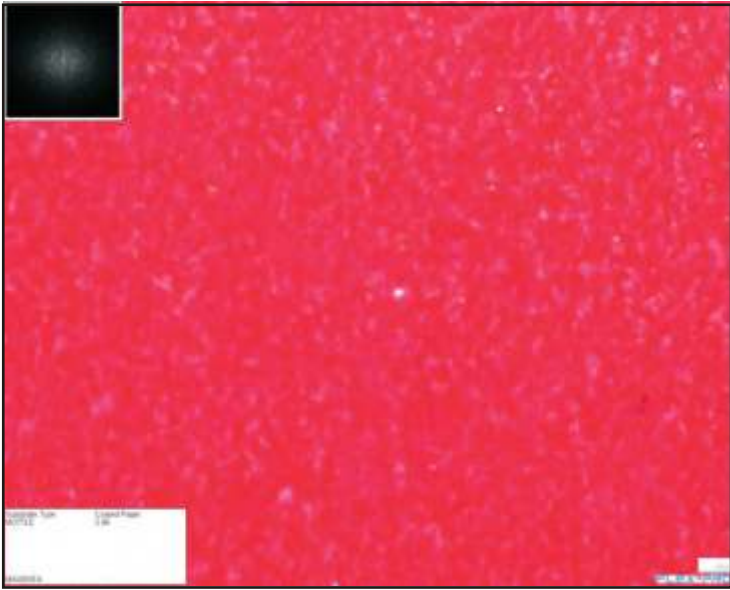
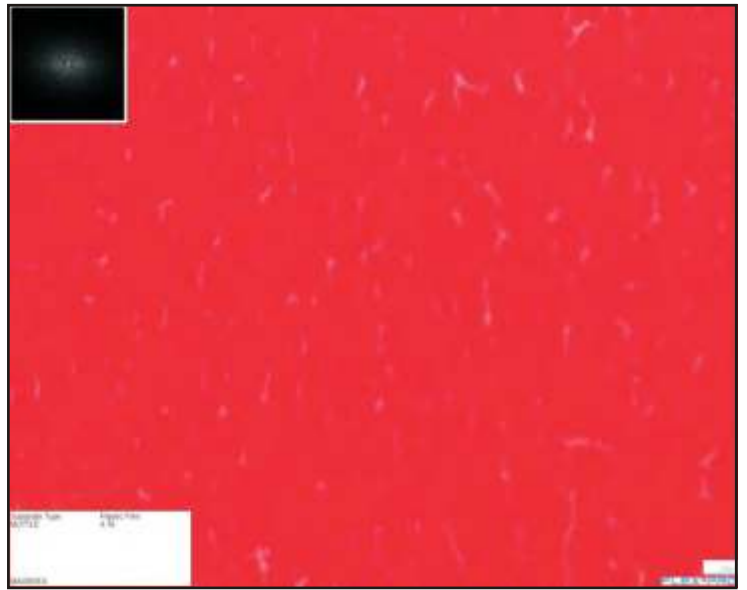
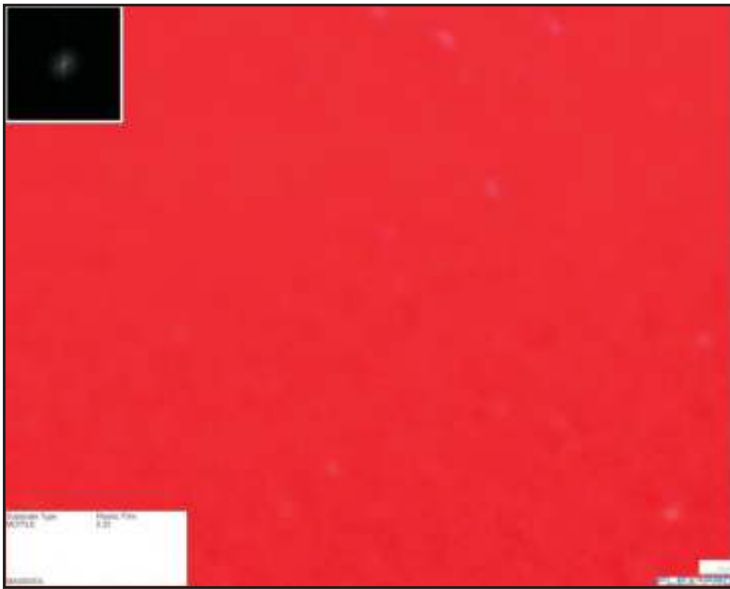
The images below represent various levels of mottle. The image name represents the measured mottle value as calculated by a new algorithm. The geometry of the defects within the image and the range of tones represented by the defects are weighted along with other factors to produce a numeric value. This number offers excellent agreement to the expert appraisal of mottle on the physical scale involved. The field of view of the Betaflex PRO is approximately 2240 x 1780 microns. The software viewport at normal screen resolution is about 1640 x 1140 microns.
